**EXPEDIENT REPAIR OF STRUCTURAL
FACILITIES (ERSF) - VOLUME II: ERSF
SYSTEM REQUIREMENTS AND USERS
GUIDE**

D . L. READ, D. H. MERKLE

**APPLIED RESEARCH ASSOCIATES, INC.
P. O. BOX 40128
TYNDALL AFB FL 32403**

JULY 1991

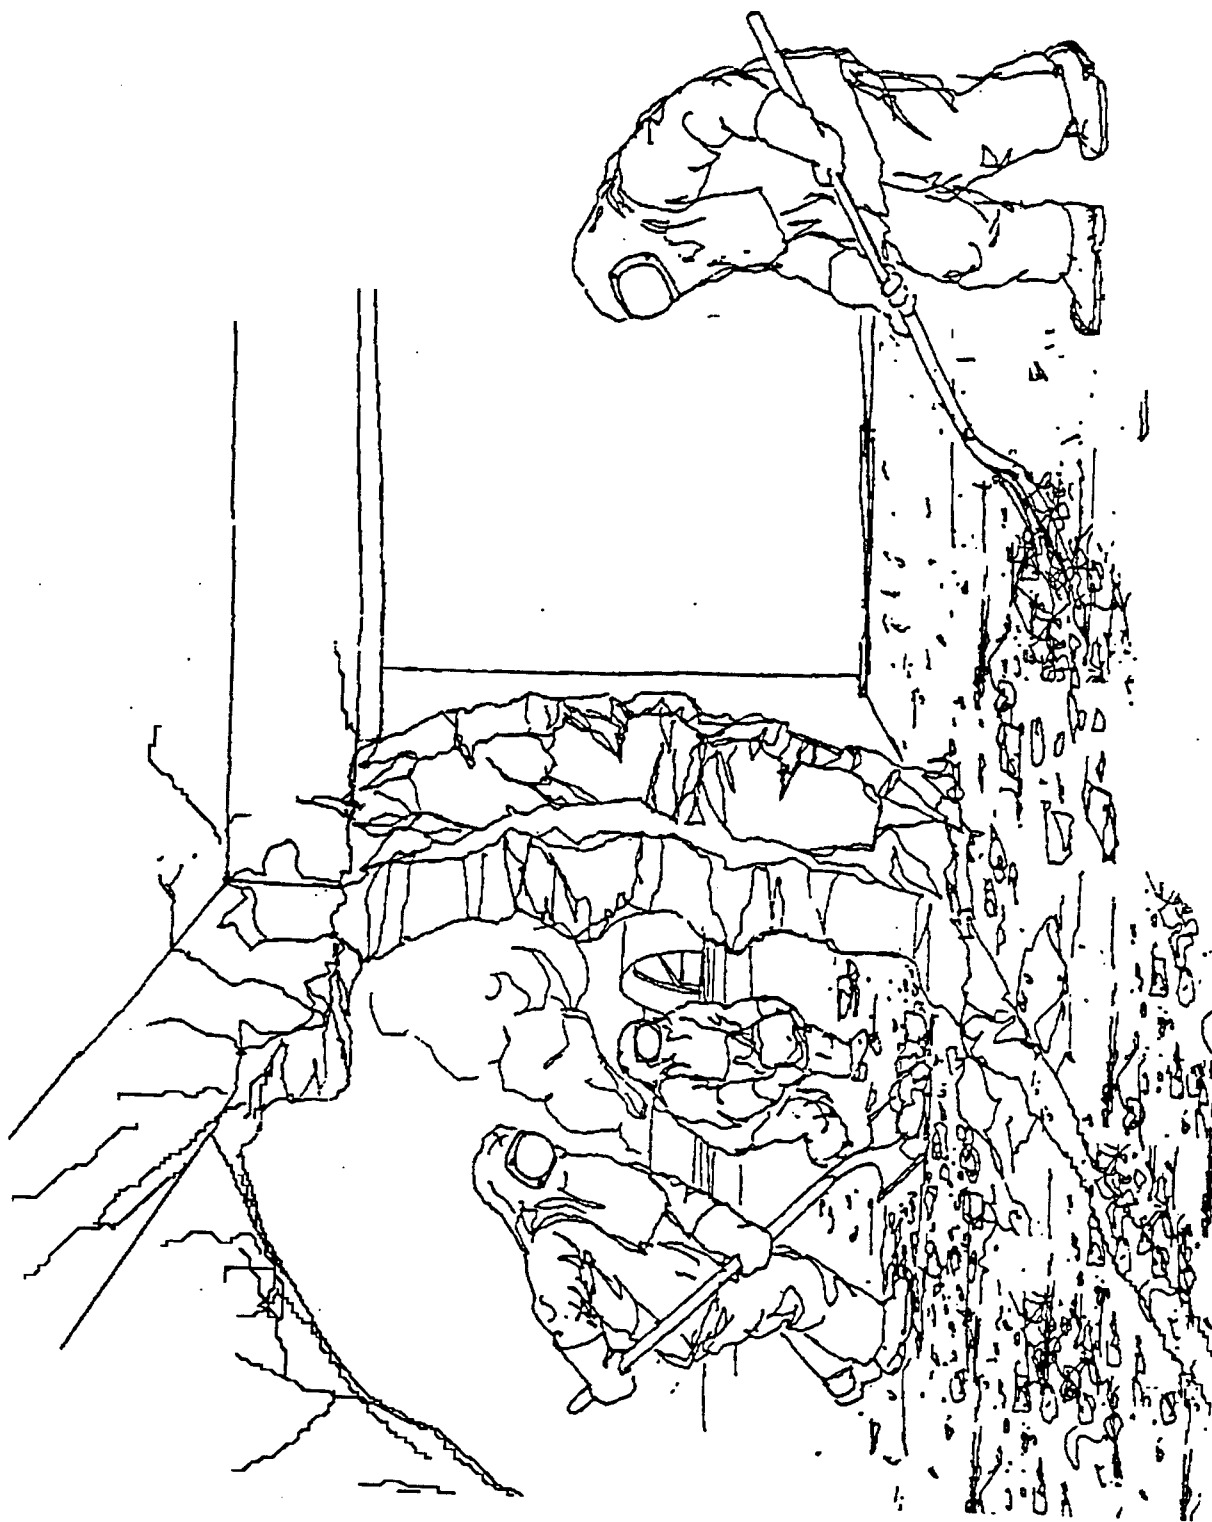
Figure 2. Debris Clearance During Column Replacement.

Figures 2 through 5 show a method for replacing a badly damaged reinforced concrete column. After clearing away debris and other interfering, non-load-bearing structural material from around the column, a shoring jack is placed beside the damaged column, then extended until its capacity is reached or repair personnel can no longer extend it, whichever occurs first. Then a glued, laminated timber (glulam) column, trimmed to the correct length, is positioned and wedged next to the jack. A 10-foot long, 12-inch square glulam column should provide sufficient capacity, while still being relatively easy to handle. The capacity of such a column is discussed in Section VI. The glulam column is braced laterally with lumber for stability, and the jack removed to be reused elsewhere, leaving the glulam column to carry the vertical load.

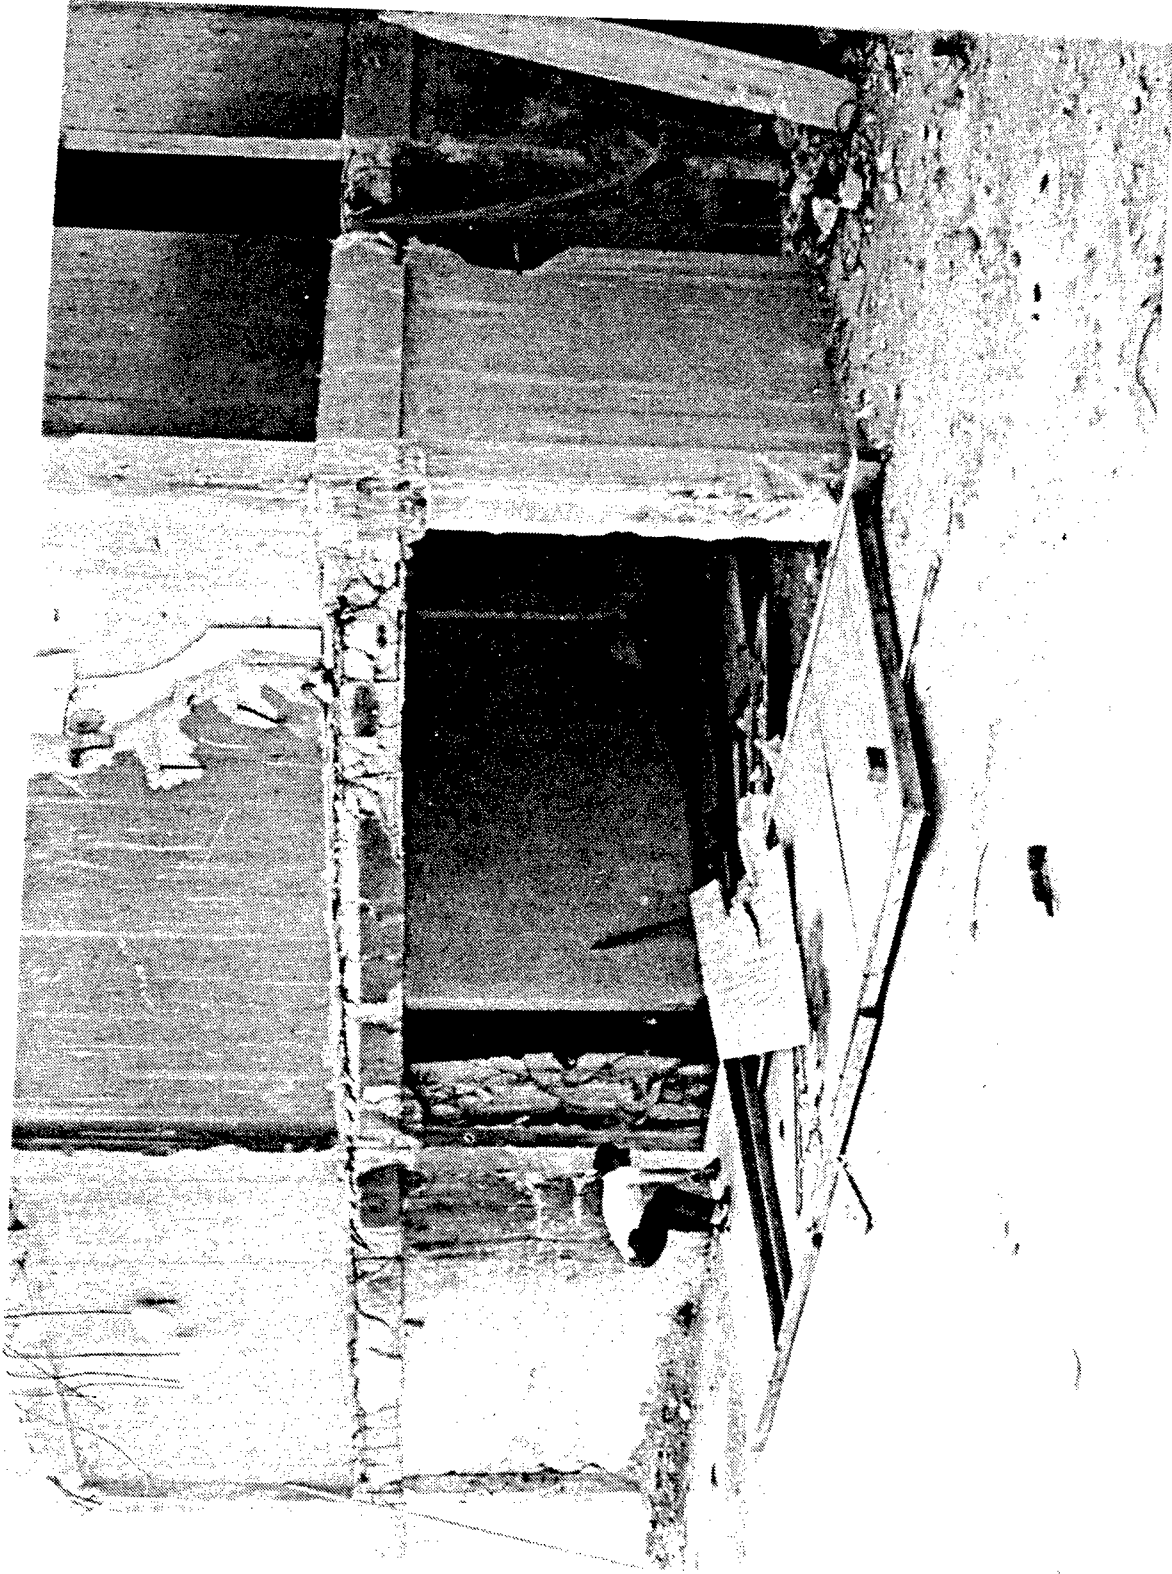
Figure 14. Destroyed Reinforced Concrete Wall.

In this damage mode, a non-load-bearing, reinforced concrete or masonry block wall has been completely destroyed, with only minimal portions of the wall remaining attached to the surrounding columns and floor or roof beams. An example of such a wall is shown in Figure 14. Candidate expedient repair methods for such a damage mode are described below.

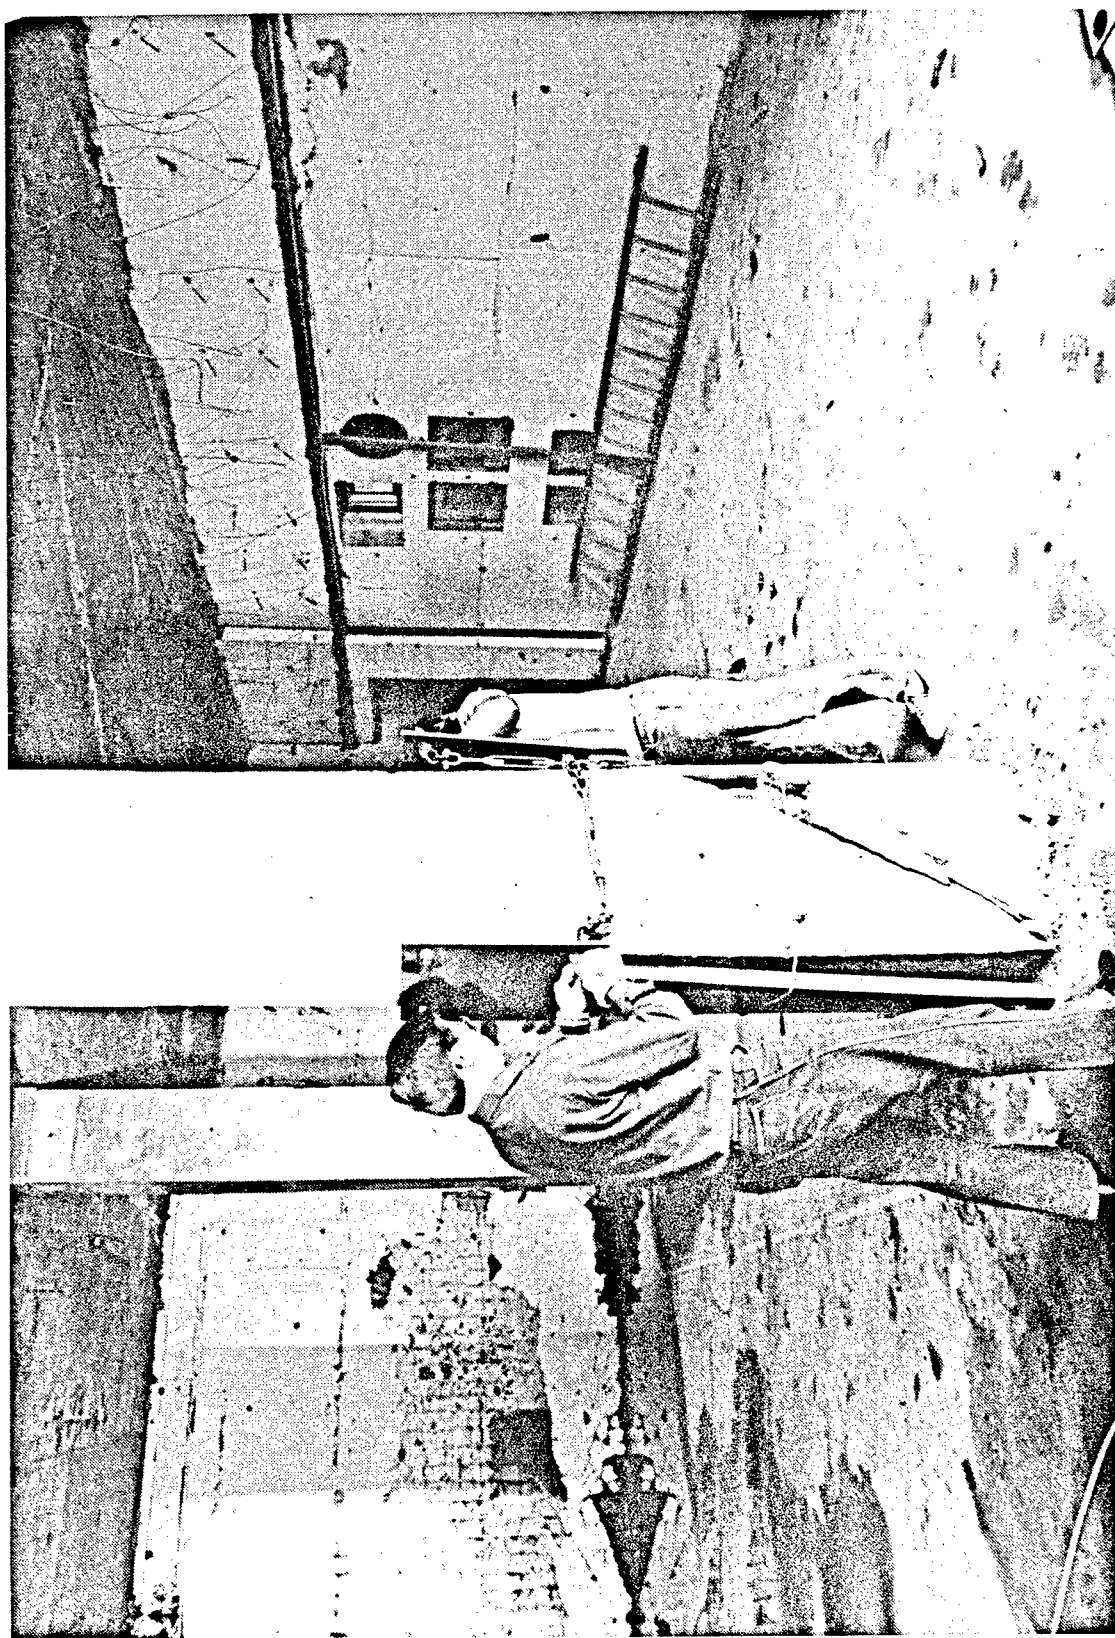
Figure 38. Positioning Splint Plates 4 Feet High On the Column.

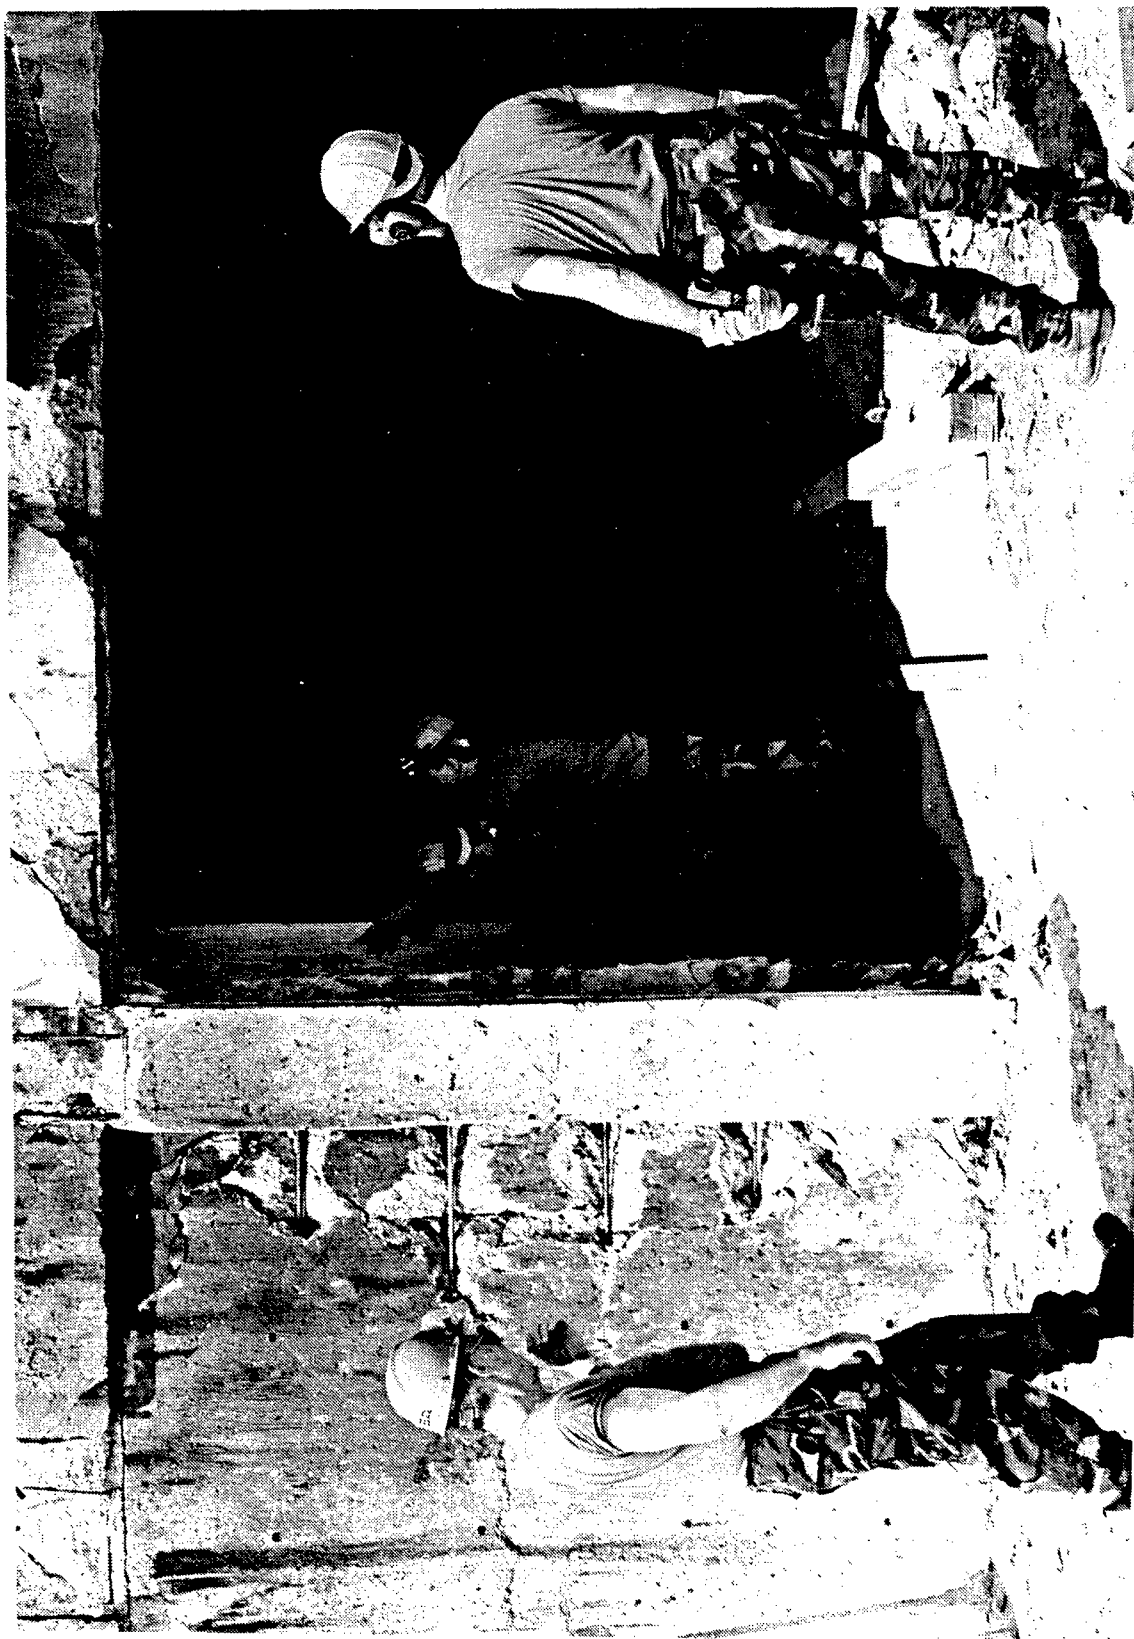
Figure 52. Placing Trimmed Glulam Timber Column Next to Shoring Jack.

Views of the column replacement process are shown in Figures 48 through 55. Debris was cleared from around the column (Figure 48). A height measurement was taken next to the damaged column, to find the required replacement column length (Figure 49). The glulam column was then trimmed to the correct length using a chainsaw (Figure 50), while a shoring jack was placed next to the damaged column and extended by hand to refusal (Figure 51). The length of the glulam column was trimmed to leave a 1/2-inch gap between the top of the column and the bottom of the roof beam. This allowed wooden wedges to be inserted between the column and the roof beam to firmly secure the column in place. The glulam column was then positioned next to the shoring jack (Figure 52), and the wedges inserted (Figure 53). Lateral bracing consisting of two-by-fours was attached to the glulam column with nails, and anchored to two-by-fours secured to the concrete floor of the structure with ramset studs (Figure 54). Finally, the shoring jack was removed (Figure 55) completing the column replacement process.

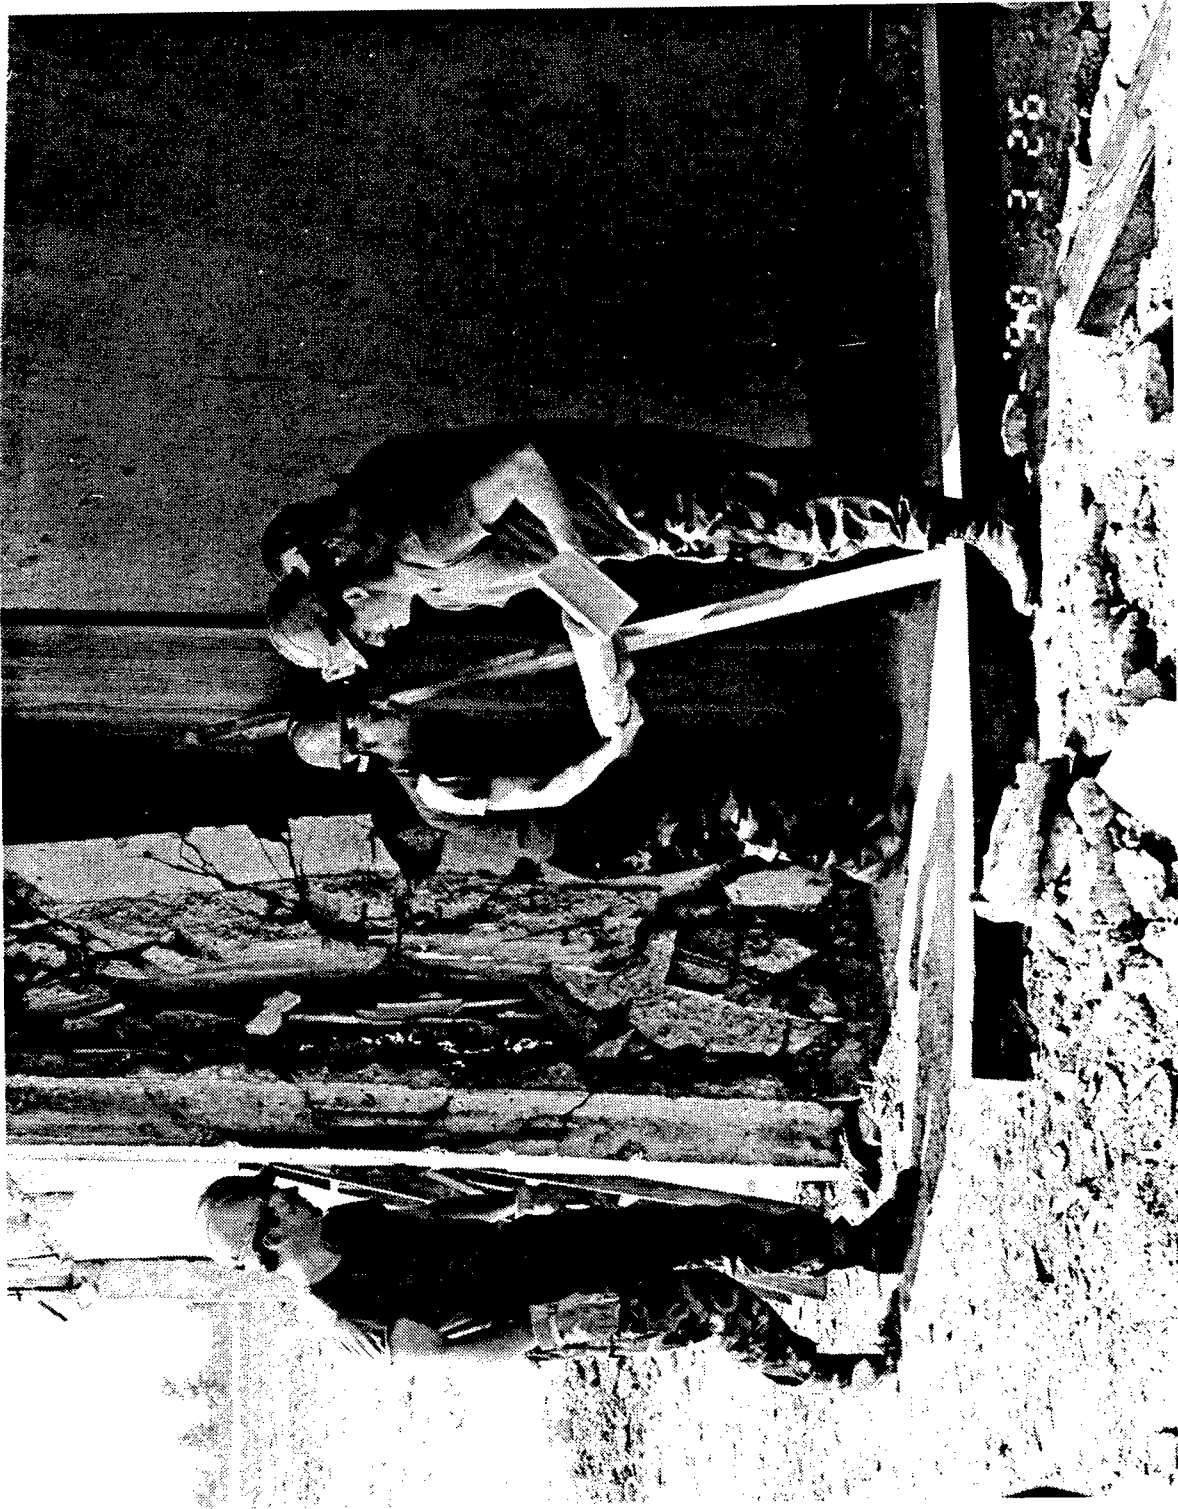
Figure 55. Removing Shoring Jack to Complete the Repair Process.

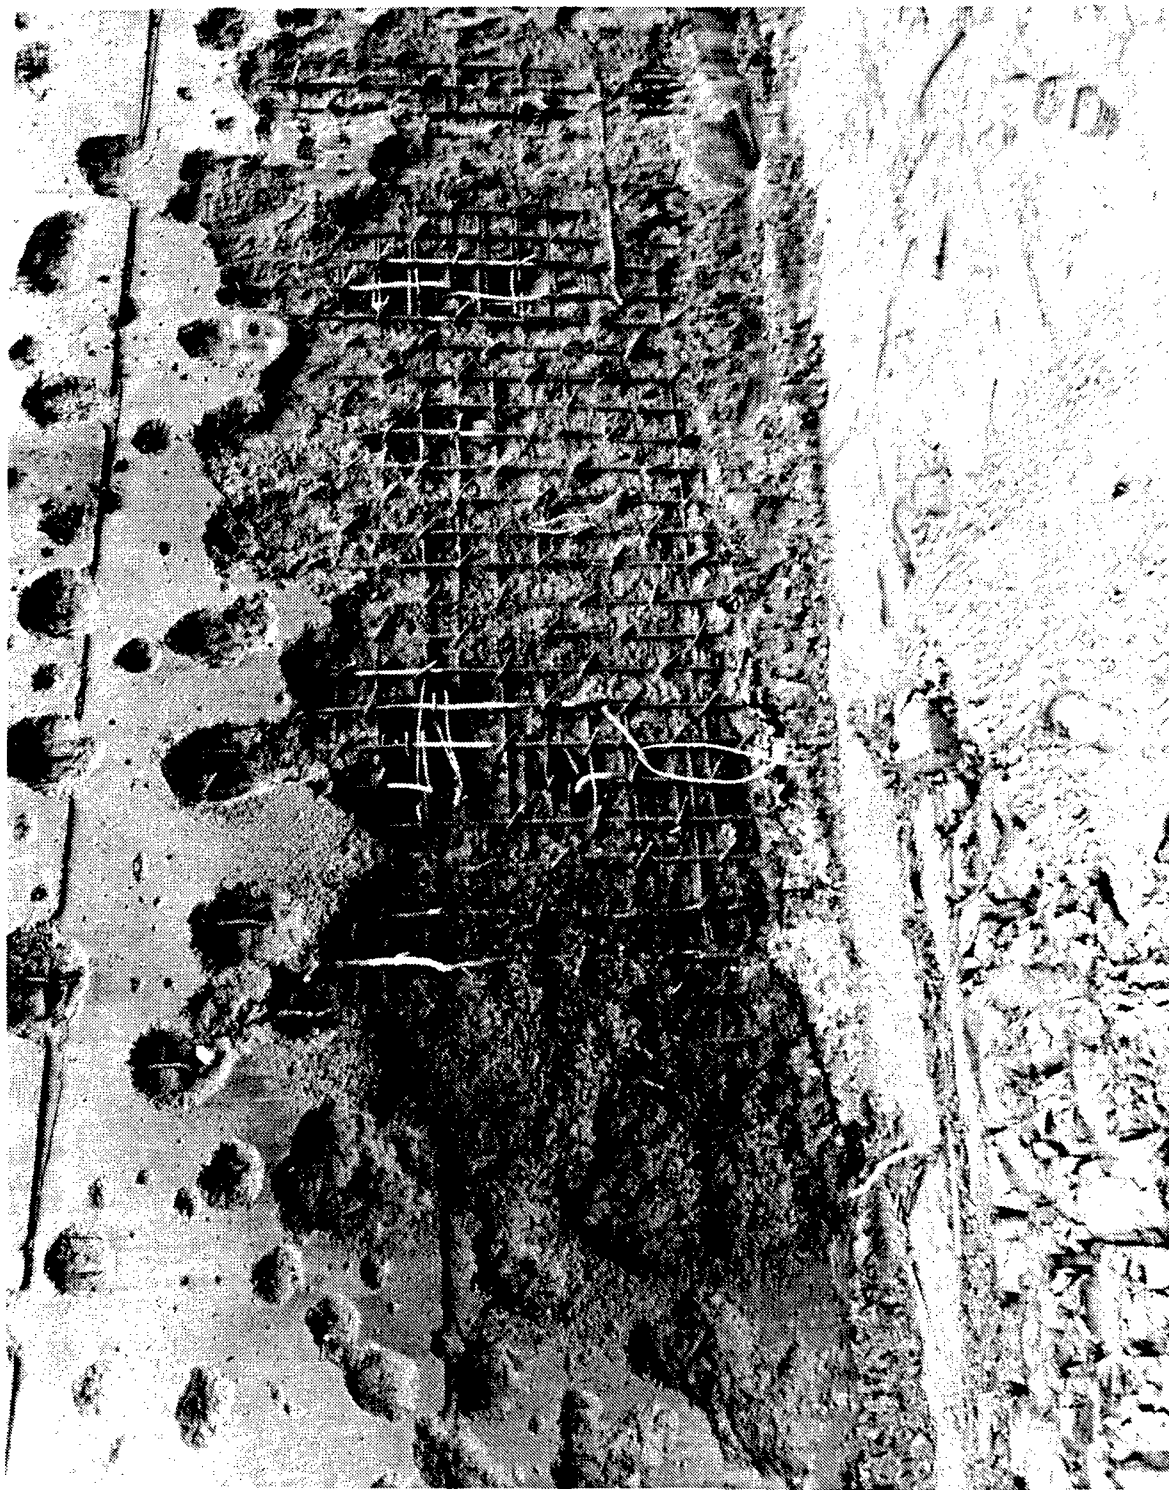
Figure 70. Completed Simulated Shotcrete Wall Breach Repair.

The repair area after shotcreting is shown in Figure 70, while the clogged feed cylinders of the shotcrete gun are shown in Figure 71. Upon investigation, it was determined that clogging of the cylinders was caused by having too large a surcharge of material in the gun hopper and wood feed funnel above the hopper. To alleviate this problem, the wood funnel was discarded, and only 3 or 4 inches of material was maintained in the hopper. Consequently, continuous monitoring of the shotcrete hopper was required, with frequent small feedings of material from the concrete bucket into the hopper. These new procedures were used during the wall replacement demonstration described below.
